**BRENT CROSS PHASE 1A SOUTH**

PROJECT NO: P2007004  
 SCHOOL LANE  
 TREE REMOVAL PLAN

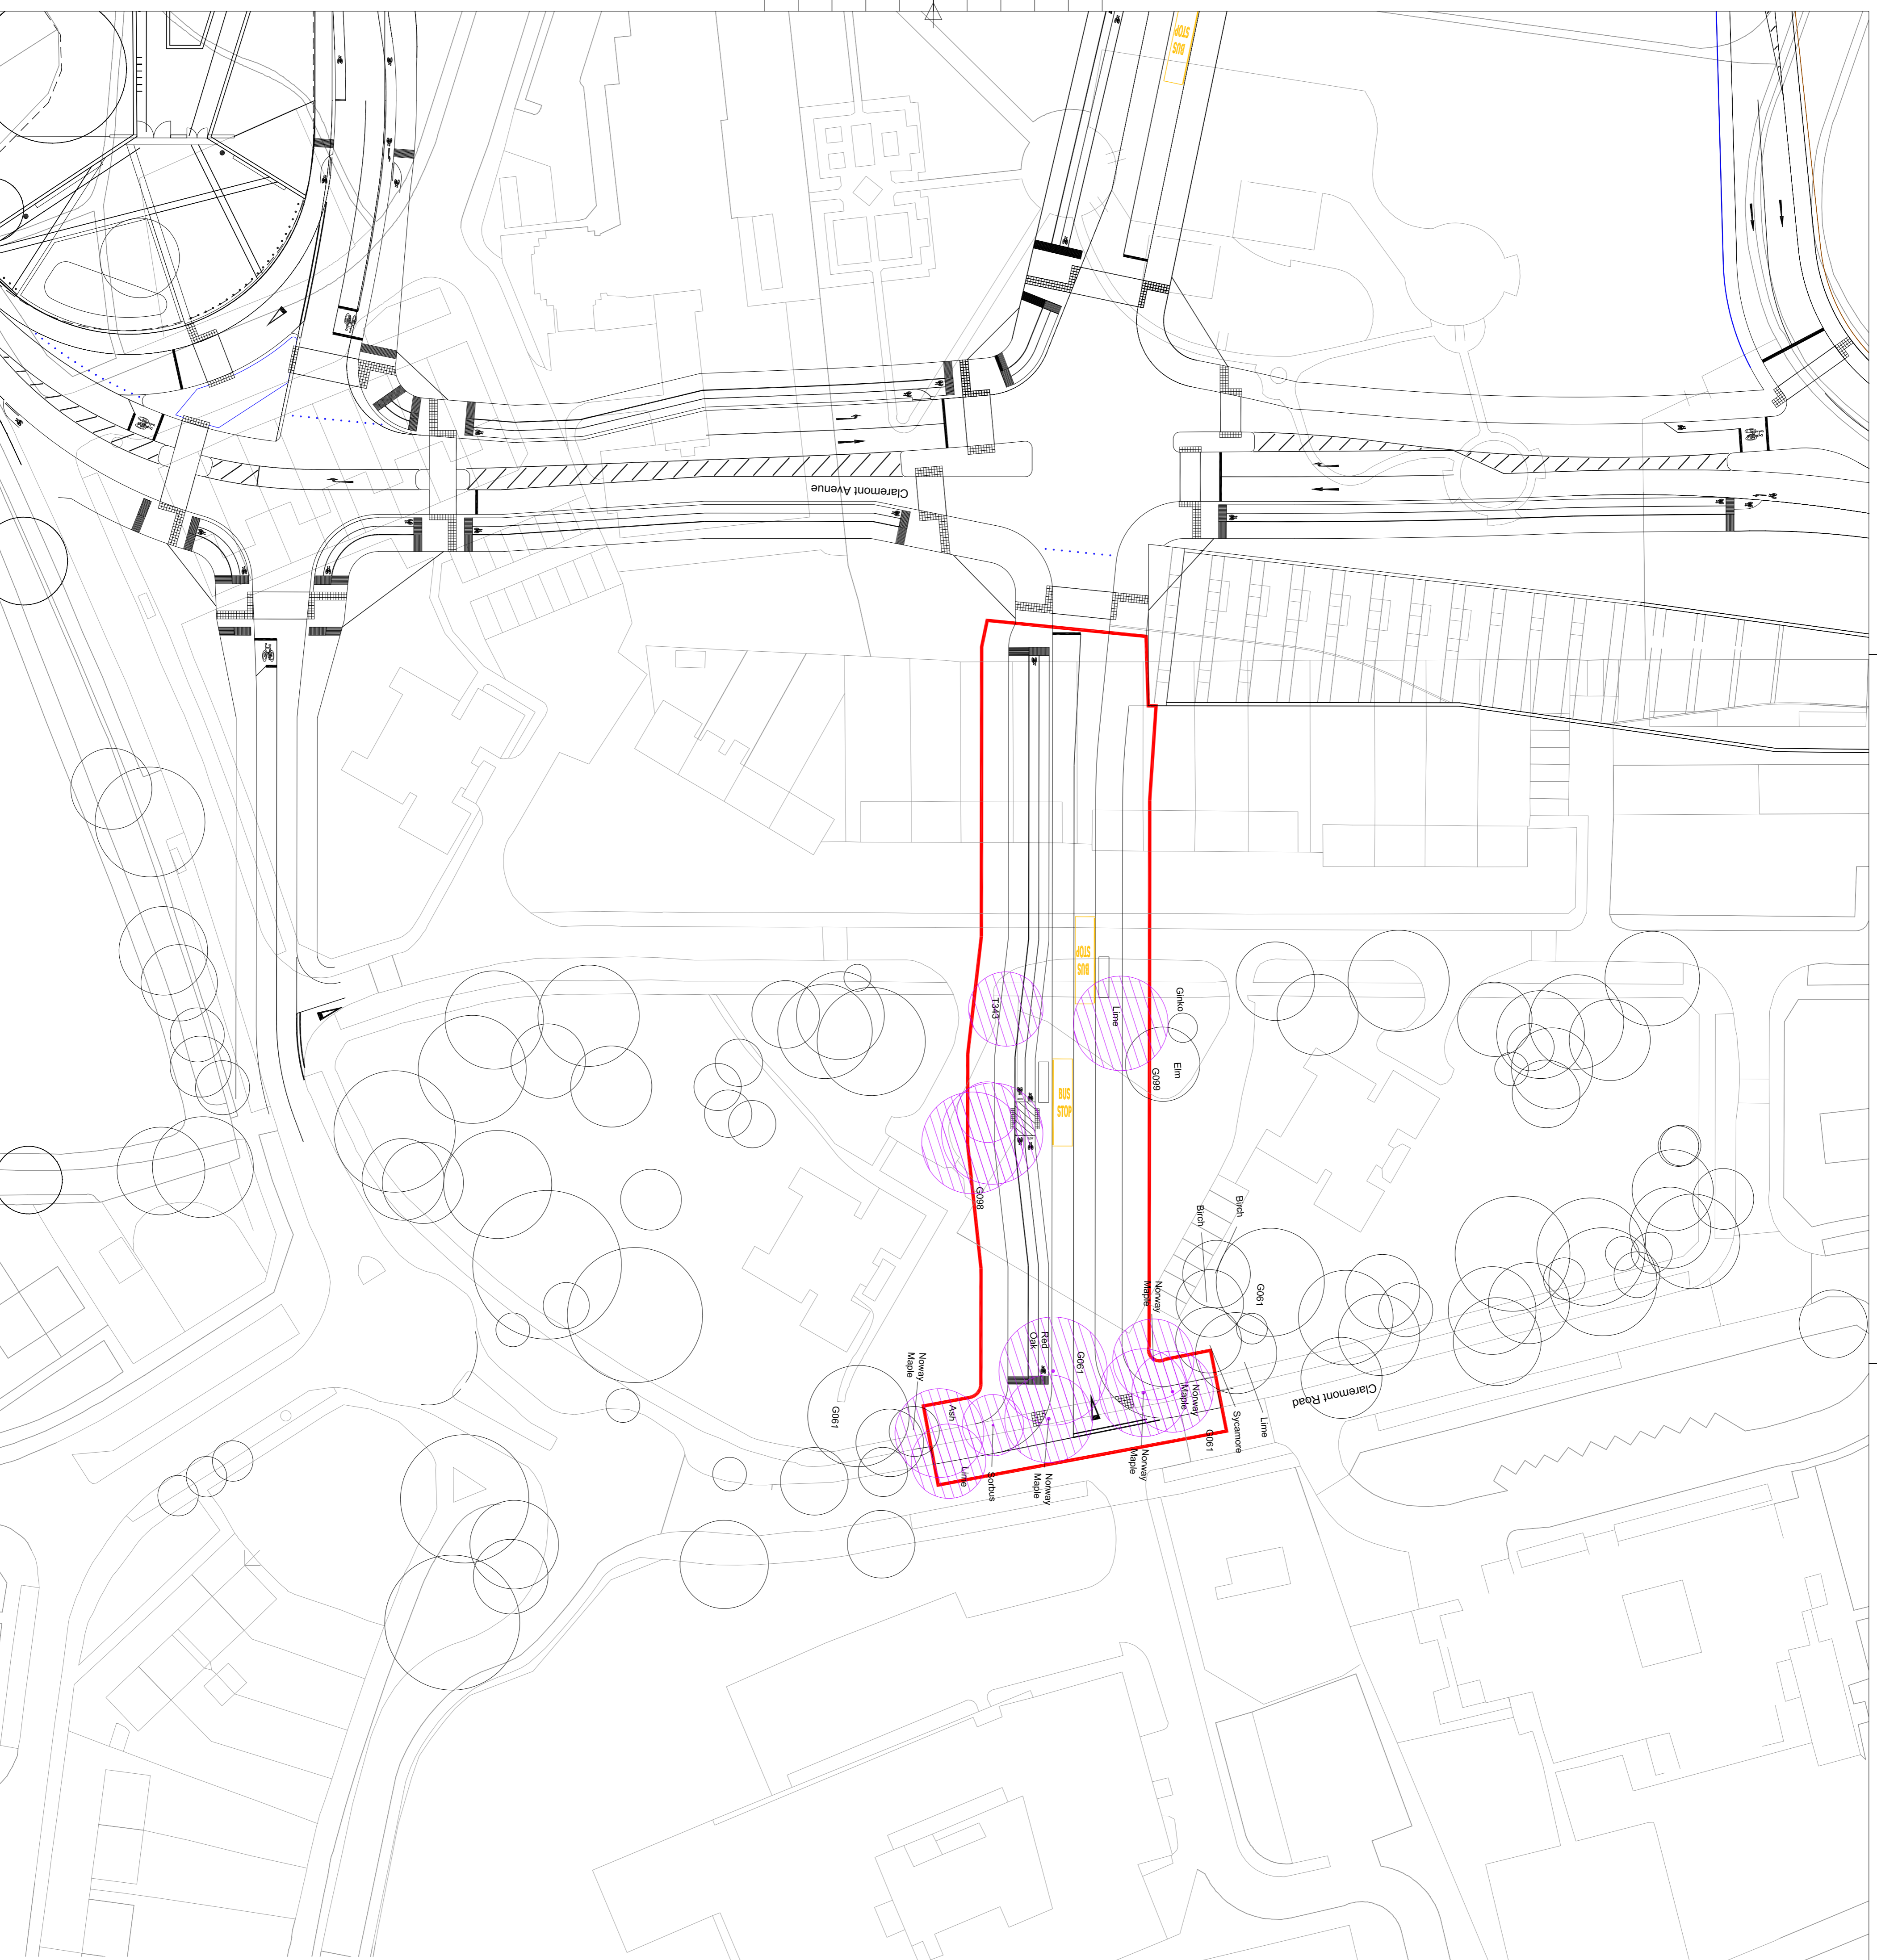
Tree Survey Reference	British Standard Category	Identified for removal in Phase 1A South*
G061	B2	Large group of trees. Some trees feature minor defects such as stem asymmetry, crown, mild deadwood. Maximum DBH crown diameter given in schedule. Accurate DBH crown diameter on drawing. Limited TOPO data. Individual constituent trees poor but coalesce to create a notable landscape feature. 4 x Norway maple, 1 x Red oak, 1 x Lime, 1 x Ash and 1 x Sorbus to be removed from this group.
G098	C2	Large group of trees. All trees feature significant defects. Weak unions on scaffold limbs. Included bark. Trees with landscape value but significant defects. Small group of trees. All trees feature minor defects. Weak unions on scaffold limbs. Bark wounds on base of stem. Bark wounds on main stem. Poor form. Individual constituent trees poor but coalesce to create a notable feature. 1 x Lime to be removed from this group.

G099	C2	Highways tree. No indicators of disease/decay/structural defects. Minor deadwood. Restricted root zone. A tree with slight impaired condition.
T343	B2	Table identifies only those trees and groups of trees affected by the proposals in or within 10m of the application boundary. Commentary from Arboricultural Impact Assessment/Tree Survey Schedule May 2015 (Revision C)

The position, condition and dimensions of the trees are based on a site survey undertaken on 12/02/14  
 The original of this drawing was produced in colour - a monochrome copy should not be relied upon  
 All existing trees to be removed as approved under Condition 27.1 for Phase 1(A/N) RMA are not shown on this plan. This plan only shows additional trees to be removed within 10 metres of the Phase 1(A/S) RMA boundary.
